# Masonry Barn Design and Construction

BY HENRY GIESE, H. J. BARBE AND J. BROWNLEE DAVIDSON

AGRICULTURAL EXPERIMENT STATION  
IOWA STATE COLLEGE OF AGRICULTURE  
AND MECHANIC ARTS

AGRICULTURAL ENGINEERING SECTION

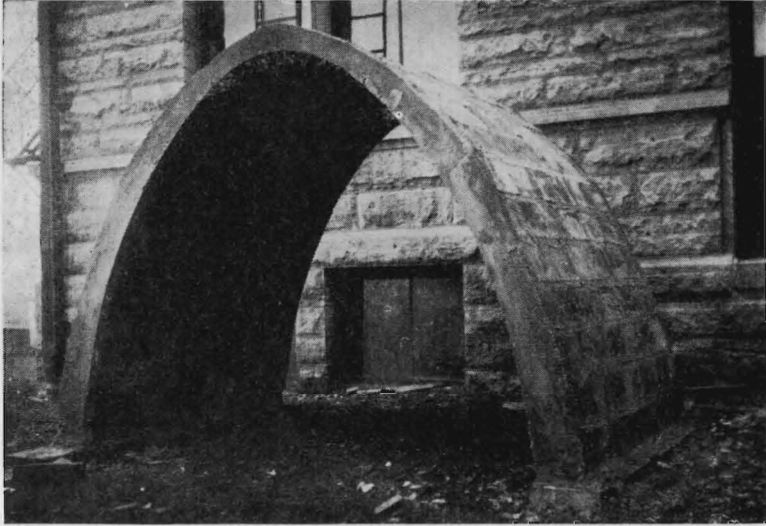
Fig. 7. The model arch roof.

A model of one section of the roof of the proposed design was constructed to a scale (4 inches=1 foot). (See fig. 7.) In recommending a method for the construction of the roof, the following problems seemed to deserve the greatest consideration: (1) The cost of the materials and labor for the construction of the forms; (2) the necessary scaffolding for the mason; and (3) placing the materials within the mason's reach.

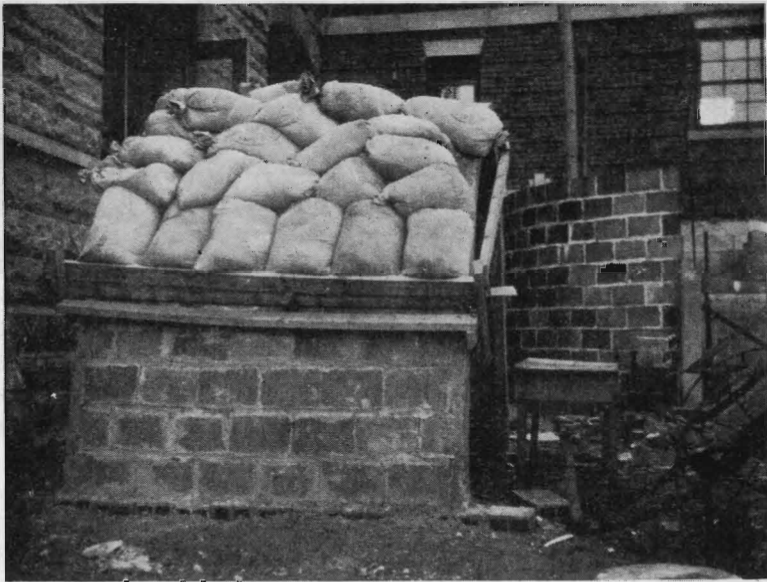
Fig. 8. Manner of loading the model roof for the strength tests.

Two weeks after the arch had been constructed, 23 sacks of sand, each weighing 100 lbs., were placed on one side of the roof to simulate wind load conditions (fig. 8). No cracks or severe deflections could be detected at any point along the arch ribs.

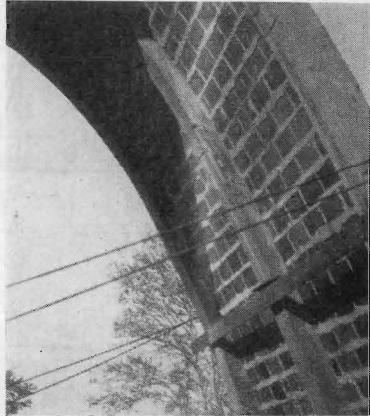
Fig. 13. Failure of middle rib. Concrete spalled from the reinforcement at the point where the bars overlapped.

The failure which occurred slightly above the point of application of the load (fig. 13) was not typical of a reinforced concrete beam, but seemed due to the fact that all laps in reinforcing bars were made in one place, making such a mass of steel that the individual bars were not surrounded with concrete.

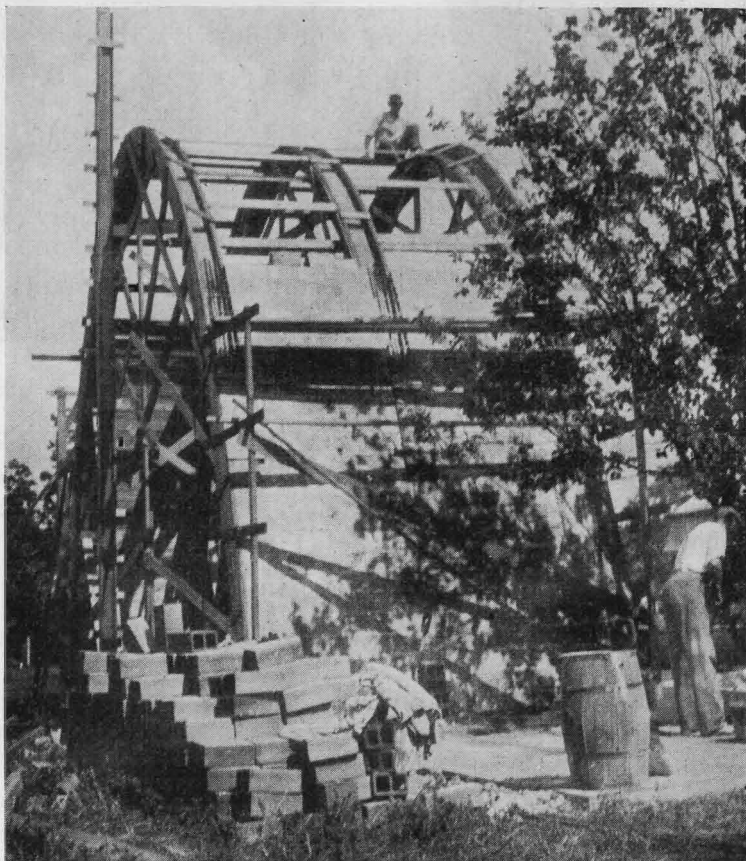
Fig. 25. Construction of the full sized arch roof section.

The tile were laid in each section, keeping both sides of the arch about the same height in order to better distribute the loading on the forms (fig. 25). The concrete for the ribs was

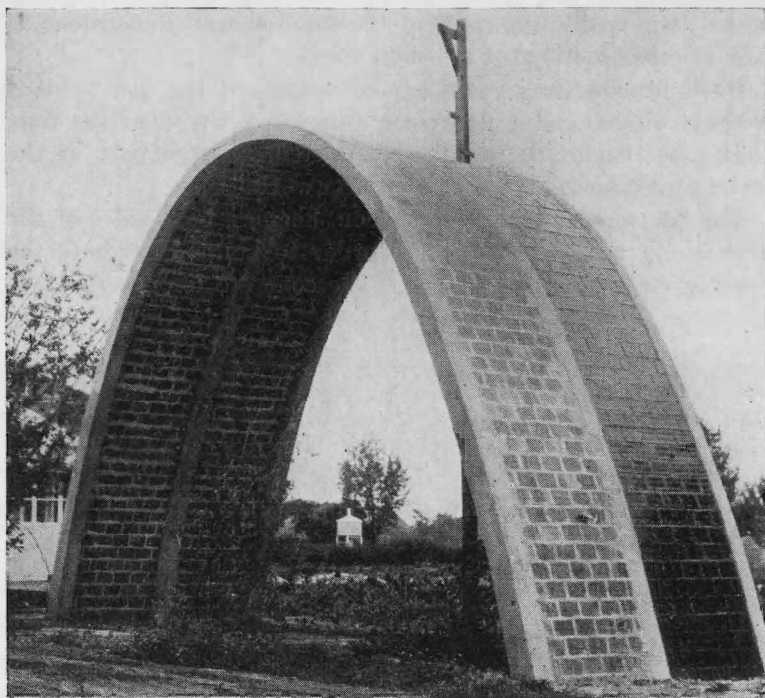
Fig. 26. The completed section of the full sized arch.

poured after the sections of blocks were laid. This ran back into the openings of the tile, securing a good bond between the rib and the hollow clay block sheathing. The completed section is shown in fig. 26.
